**EHLINGER & ASSOCIATES**

**SECOND QUARTER 1990**

## **TEMPLE OF AMMON, MUT AND KHONS AT LUXOR, THEBES, EGYPT**

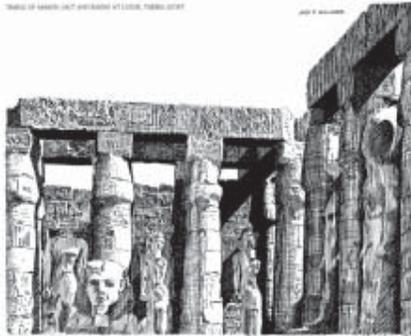
The Temple at Luxor (1408-1300 B.C.), though founded on an older sanctuary, and like most temples altered and repaired subsequently, is substantially the work of Amenophis III, except for a great forecourt with pylons, added by Rameses II. The temple was dedicated to the Thebian triad, Ammon, Mut and Khons. This issue's limited edition signed print by Ladd Ehlinger illustrates the forecourt with the papyrus-bud shaped capitals on the columns and a seated colossus of Rameses, looking toward the sanctuary. The statues between the columns in the background are the deities. The bud shaped columns are 24' high and comprise twin colonnades connecting the sanctuary with the hypostyle hall leading to the forecourt, which was never finished by Amenophis.
