ARCHITECTURE

EHLINGER & ASSOCIATES

THIRD QUARTER 2002

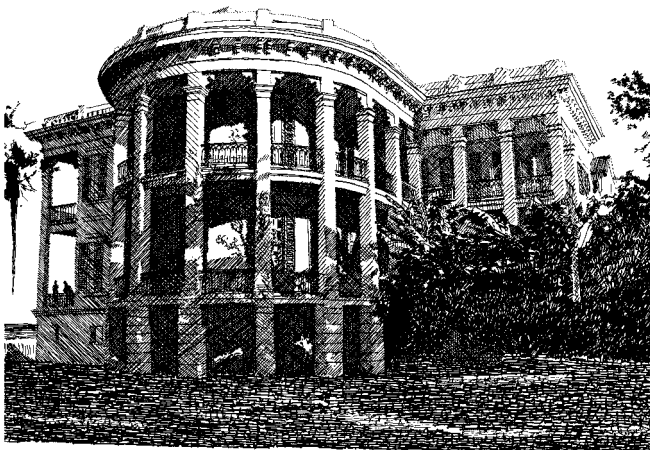
NOTTOWAY PLANTATION
Whitecastle, Iberville Parish, Louisiana, USA
© 2002 Ladd P. Ehlinger

The main house is placed about 200 feet from and faces the Mississippi River among oaks, magnolias, pecan trees and sweet olives. It is composed of 64 rooms on three levels with the crowning achievement being the semi-circular Ballroom on the first level, with the Master Bedroom above that can be seen in

the sketch in the center. The columns and brackets and the 200 or so windows are all tall and narrow in the Italianate style. The entablature is heavy and with the Italianate brackets is close to the evolving Victorian style. The balustrades are cast iron as most of the New Orleans balconies were, but of Italianate motifs. The exterior and interior of Nottoway is white in color, including the interior Ball-

room Corinthian columns, marble mantels, curtains and even the floors.

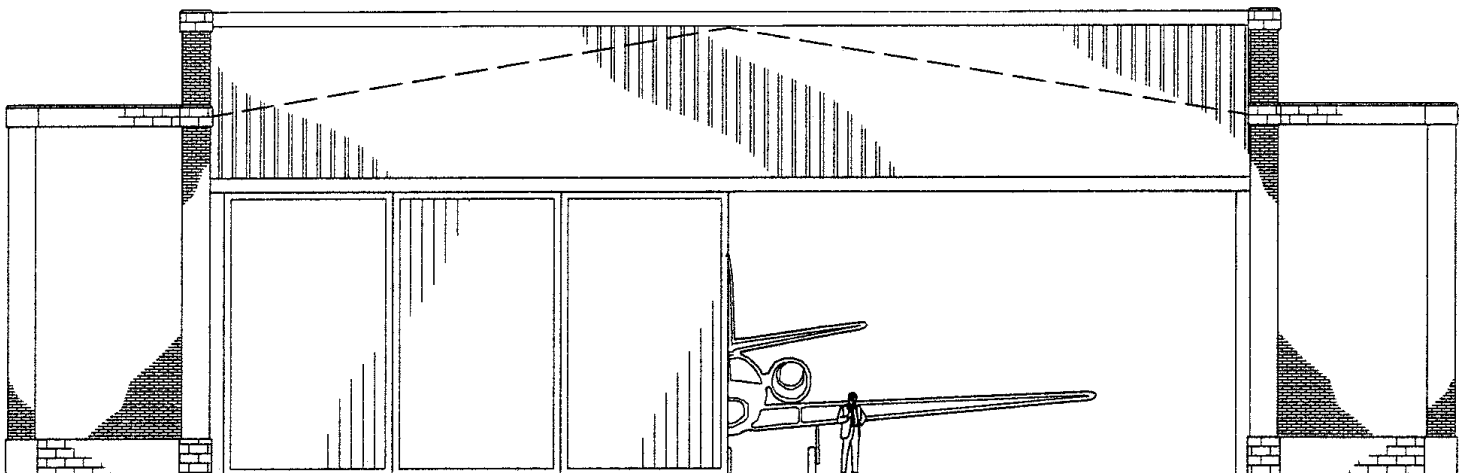
The sketch below is of the front elevation of a new hangar, part of a new terminal and hangar project that E&A is doing for the City of Scottsboro, Alabama.
