# ARCHITECTURE

EHLINGER & ASSOCIATES

FIRST QUARTER 2011

## Grace United Methodist Church

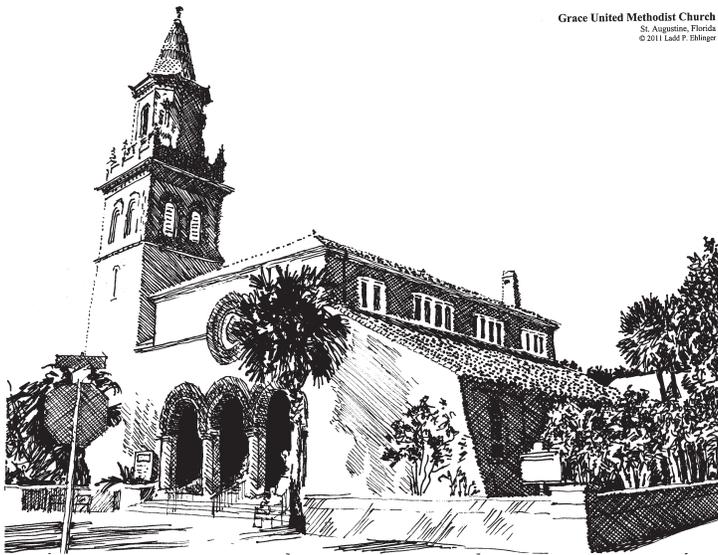
Grace United Methodist Church  
St. Augustine, Florida  
© 2011 Ladd P. Ehlinger

Grace United Methodist Church in St. Augustine, Florida, this issue's limited edition print of a sketch by Ladd P. Ehlinger has a very interesting history, besides being an archetype of what I would call "Robber Baron Architecture". This building is actually the second building the congregation had designed and built. The first was built in 1884 and was closer to the Ponce de Leon Hotel being built by Henry Flagler. Shortly after completion, Flagler decided that he needed the property to further complete the hotel, so he offered in 1886 to buy the first building and furnish property and build a new church further north on Cordova St. at Carrera in St. Augustine. The congregation accepted Flagler's offer, and work began on the new facility in 1886.

Carrere and Hastings were fairly inventive and bold architects. They made use of concrete as the major wall material of the Grace Church project. This was very daring at the time because concrete had only recently been re-discovered as a building material since the fall of the Roman empire. Architects and engineers were not accustomed to the material at this time, yet the finish on the walls is one of exposed aggregate, and there was tight control of the type of aggregate used in the concrete so as to control the color. There was however a lack of knowledge about reinforcing

The interior of Grace is of heavy timber construction, with stained and varnished structural members and decking, along with intricate millwork. This was all beautifully designed and constructed in Grace as in their other buildings.
