GALLERIA VITTORIO EMANUELE II

E EHLINGER & ASSOCIATES, P.C.
ARCHITECTS - A PROFESSIONAL CORPORATION

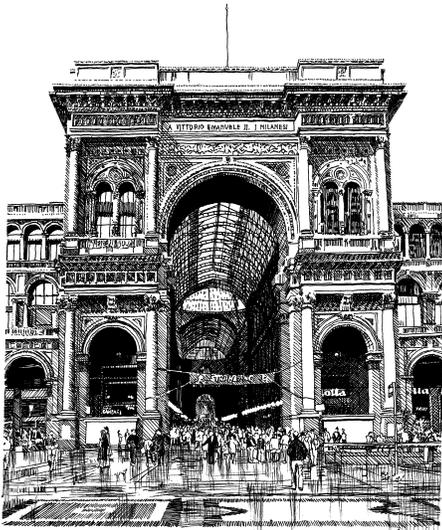
Galleria Vittorio Emanuele II in Milan, this issue's limited edition signed print by Ladd P. Ehlinger, is a paradigm of architecture for retail use. It was started in 1829, the same time the similar Galerie d'Orleans (now destroyed) in Paris was begun, and finished in 1877. The architect was G. Mengoni.

The plan of the Galleria is cruciform with an octagonal iron and glass dome at the crossing, and with all of the main entrances at the ends of the arms of the cross. One of these entrances fronts on the main square of Milan. All of the facades are of masonry in the Baroque style, three stories tall with huge pilasters spanning two of the three stories support-

ing the ribs of the iron and glass roof structure over the arcades. The peaks of the barrel vaults have operable sashes for ventilation and the entrances were left open for the same reason. The retail shops all have show windows on the exterior and on the interior under the vaults.

The Galleria is also an excellent example of an iron and glass barrel vault structure in an arcade. The most spectacular, pure example of cast iron and glass (as a greenhouse) was the Crystal Palace by Joseph Paxton, an exhibition building in Hyde Park in London for the Great Exhibition of 1851. The Crystal Palace has been torn down, but you can still shop at Galleria Vittorio Emanuele II today.
