SEASONS GREETINGS

WHY SANTA CAN'T...

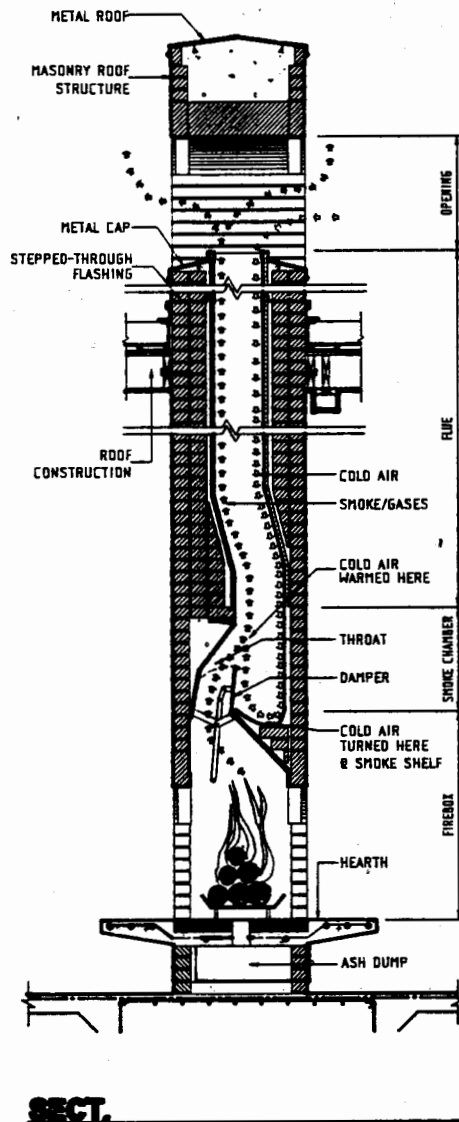
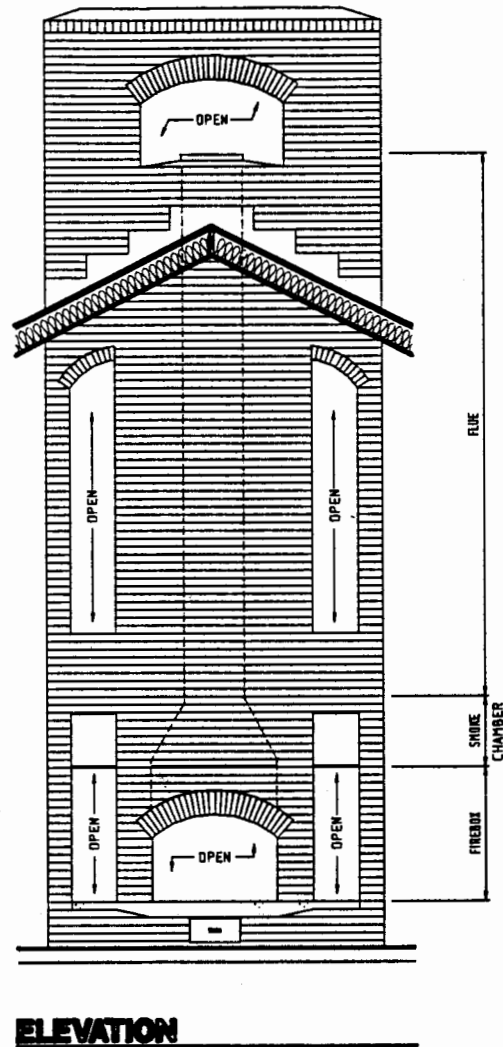
For a fireplace to work properly several aspects of the design have to be in synchronization. The firebox and its opening to the room has to be proportioned properly - width to height to depth with the throat positioned toward the firebox opening to the room such that the smoke and gases are captured before they escape the firebox into the room and they are channeled into the smoke chamber and then the chimney. It is also best that the sides and rear of the firebox are canted to direct this smoke/gas flow from the firebox to the throat as well as reflect the heat of the fire and the radiant heat absorbed by the masonry from the fire into the room.

The throat of the fire box should always be juxtaposed to the smoke chamber so that the smoke/gas effluent from the firebox enters the smoke chamber from the side of the smoke chamber. The

bottom of the throat should be directly below the top of the throat in a vertical direction. There are premanufactured metal dampers that form the throat properly, while allowing a closure of the throat when there is no fire to stop outside air entry.

This throat positioning fosters a draft upward on one side of the combined smoke chamber and flue of the smoke/gases, and a downward draft on the other side of the flue of the cold air initially in the flue, and later of the outside air. The bottom of the smoke chamber should have a smoke shelf, the lowest point of which is lower than the lowest point of the throat, that is curved to turn the cold air and mix it into the hot smoke/gases effluent at an angle such that the direction of the draft is upward. The

smoke chamber is like a vertical funnel and collects the smoke/gases from the throat and channels them to the flue.

The flue should be proportioned in size, width and depth and total height, to the firebox to contain all of the smoke/gases that the particular size firebox will emit. The flue sizes of most residential fireplaces are such that Santa will get stuck in them - 12"x16" or 16"x16" or 16"x20" - especially a fat Santa. The height in particular of the flue is important to stabilize the simultaneous upward and downward drafts within the flue.

The top of the flue as it exits the chimney should be slightly higher than the chimney, and the chimney should have a slope downward to the outside edge. It is best if there is a metal cap. This directs rainwater away from the flue opening. It is also best to have a roof above the top of the flue at a height equal to the largest flue dimension to prevent rain from entering the flue directly. Where the chimney passes through the roof system, there should be a stepped

through-flashing, which is like a metal roof within the chimney, to prevent water which saturates the portion of the chimney above the roof from draining down below the roof into the building.

When all of this criteria is not followed, Santa may have a better chance of getting down the chimney, but there will be major problems with the fireplace system. If the throat opens directly upward partially or in full to the smoke chamber and flue, the fireplace will belch smoke back into the room, and heavy rains may come in as well, because the smoke chamber floor, when constructed properly, stops any stray rainfall that breaches the roof from entering. If there is no roof or no stepped through flashing, water migration through the chimney will promote leaks and rot of wood framing.
